# **INDOOR AIR QUALITY ASSESSMENT**

**Williams Middle School  
200 South Street  
Bridgewater, Massachusetts**

Prepared by:  
Massachusetts Department of Public Health  
Bureau of Environmental Health Assessment  
August 2002

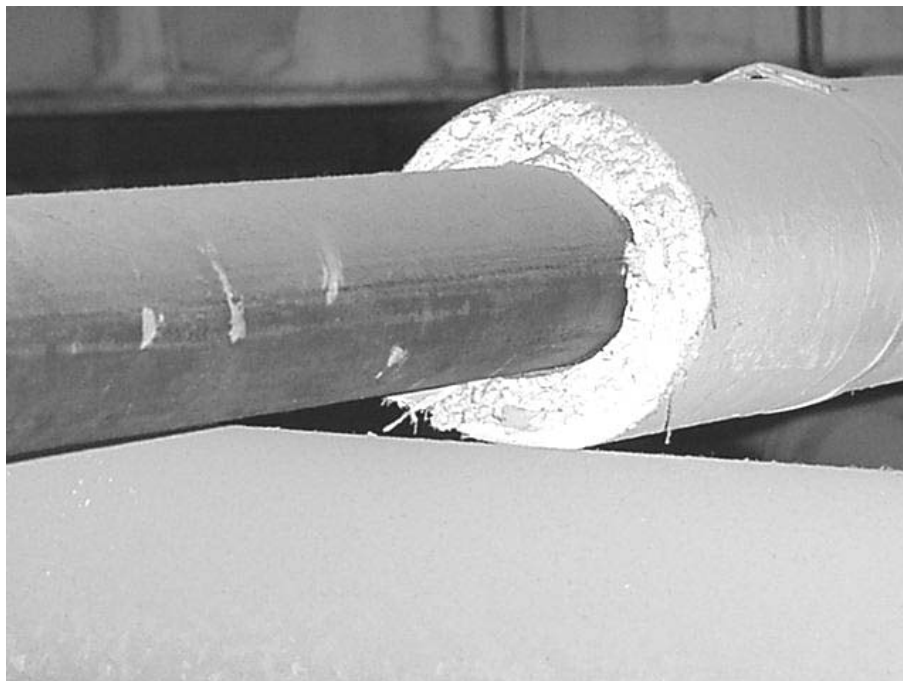
**Picture 27**

Exposed fiberglass pipe insulation was noted in the art room, the girl's locker room, and room 101A. Airborne fiberglass particles can serve as a skin and respiratory irritants to sensitive individuals. Occupant concerns of damaged pipe insulation were expressed in classroom 210. BEHA staff also noted exposed pipe insulation in the art room storage loft, which may contain asbestos (see Picture 27). This finding was reported to WMS officials and maintenance staff upon discovery. The material was reportedly encapsulated the following morning by a licensed member of the Bridgewater Public Schools (BPS) maintenance staff. This was confirmed by BEHA staff (see Picture 28).

**Exposed Pipe Insulation above Art Room**

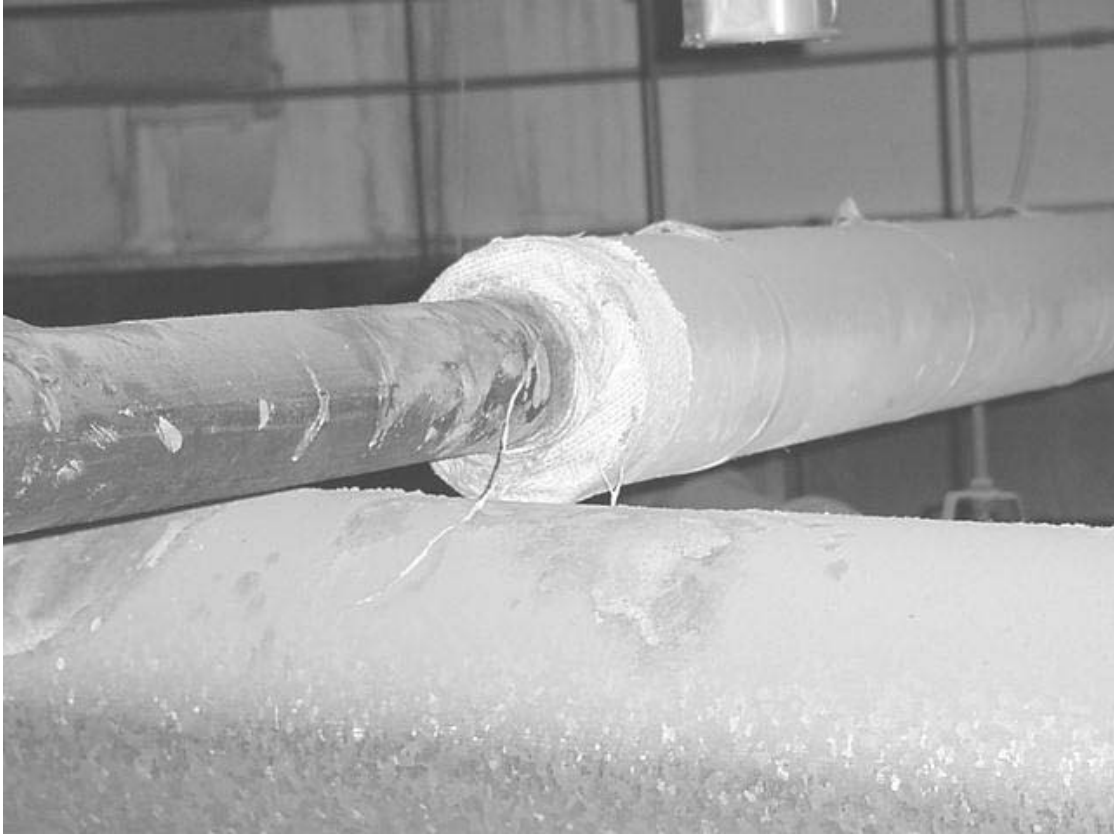
**Picture 28**

**Encapsulated Pipe Insulation Shown in Previous Picture**
